POST-OCCUPANCY ASSESSMENT

**Massachusetts Teachers' Retirement System
500 Rutherford Avenue
Charlestown, MA**

Prepared by:
Massachusetts Department of Public Health
Bureau of Environmental Health
Indoor Air Quality Program
December 2016

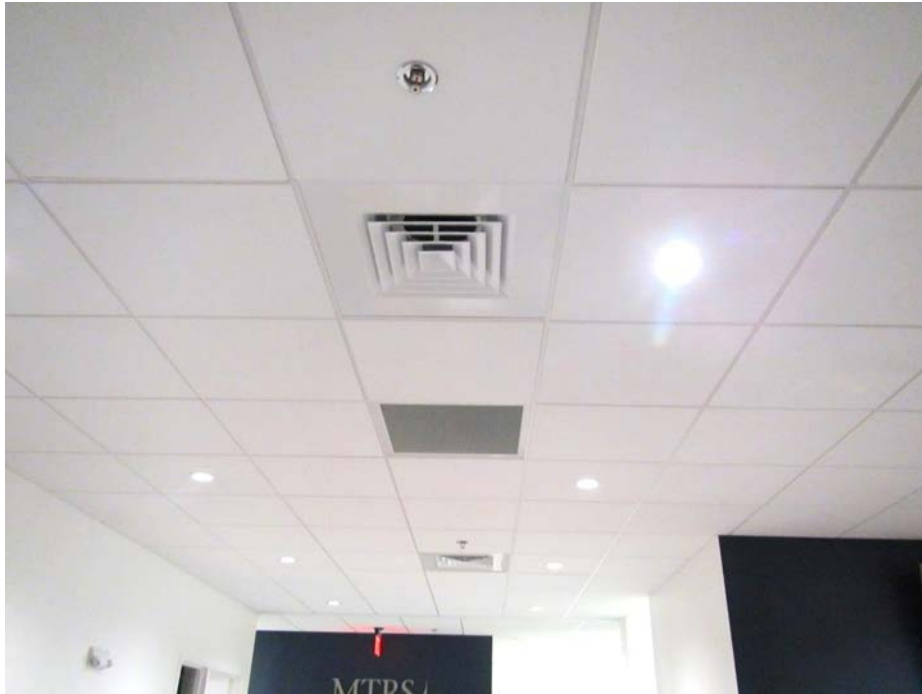
Picture 1

Fresh air is provided by rooftop air handling units (AHU) that draw fresh air from intakes on the roof. The space utilizes a ducted supply system and ceiling-mounted supply vents (Picture 1). Return vents draw air back into the AHU. The HVAC system was reportedly recently balanced prior to the pre-occupancy assessment.

Two supply and one return vent

1. Operate supply and exhaust ventilation continuously in all areas during occupied periods. Ensure all HVAC equipment is maintained and supply and return vents are cleaned periodically to prevent dust re-aerosolization.
2. Ensure thermostats are programmed to allow fan “on” when the building is occupied.
3. As mentioned in the pre-occupancy report, consider upgrading the filters in the AHU from MERV 7 to MERV 8 or higher, if this has not been done already. Change filters in accordance with manufacturer’s recommendations.
4. If the item next to the thermostat shown in Picture 2 is a carbon dioxide sensor, ensure these are calibrated or replaced in accordance with manufacturer’s recommendations.
5. Keep plants in good condition, avoid overwatering, and remove from the airstream of heating and ventilation equipment.

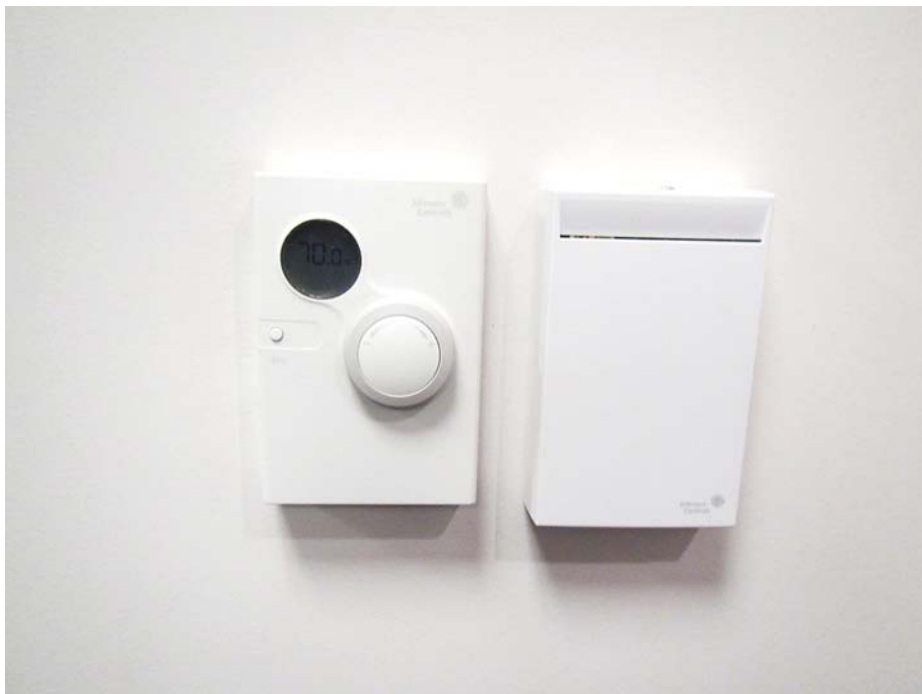
Picture 2

The assessment results indicate that the ventilation system is providing adequate fresh air for the occupancy in the building. In the conference room, what appeared to be carbon dioxide sensors were located next to the thermostats (Picture 2) to direct the ventilation system to provide more fresh air during periods of high occupancy. These should be calibrated or replaced in accordance with manufacturer's recommendations.

Thermostat in meeting room (on left) with what appears to be carbon dioxide sensor

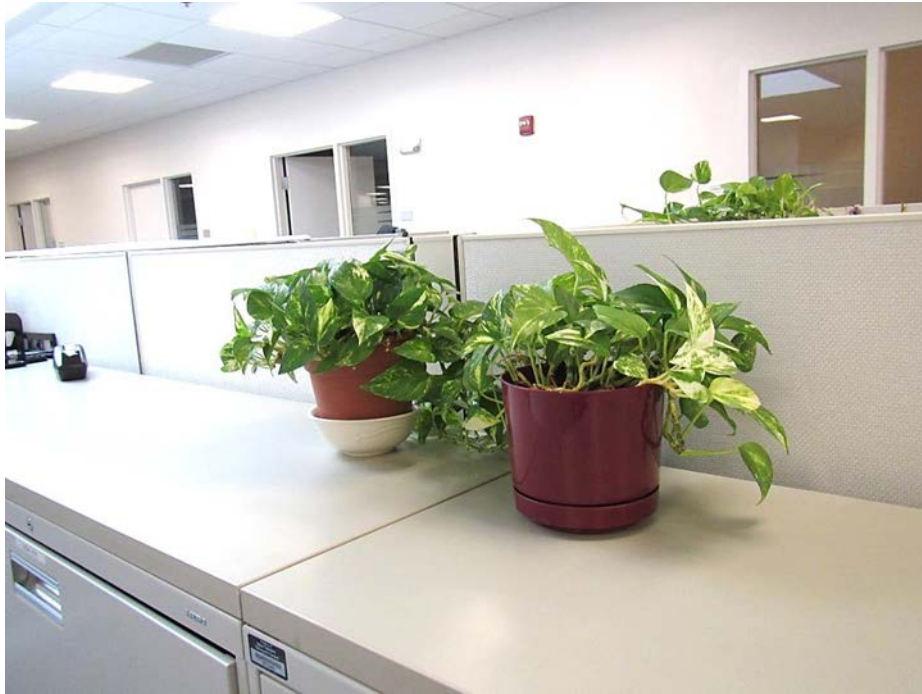
Picture 3

Plants were observed in a few areas (Picture 3; Table 1). Plants can be a source of pollen and mold, which can be respiratory irritants to some individuals. Plants should be properly maintained and equipped with drip pans and should be located away from air diffusers to prevent the aerosolization of dirt, pollen, and mold.

Plants on a cabinet

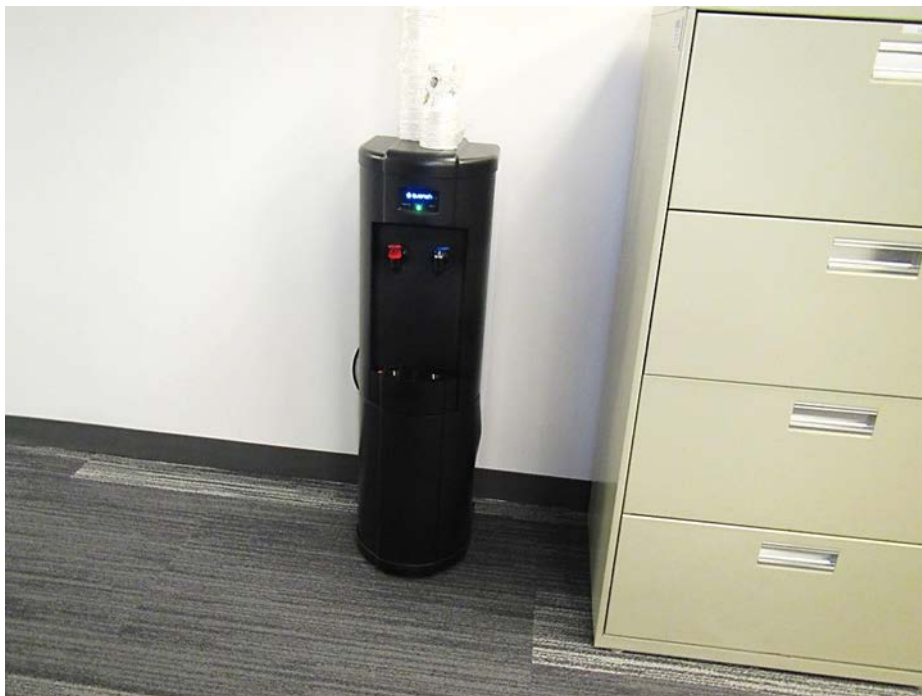
Picture 4

Water dispensers were observed on carpets, where leaks can damage carpet and lead to microbial growth (Picture 4). Drinking water for these units is produced by a reverse osmosis system, the machinery for which is located in a utility room (Pictures 5 and 6). Note that this system has an active drain for the wastewater from the operation of the system. This system should be regularly maintained in accordance with manufacturer's instructions and should be monitored regularly to ensure the drain has not clogged. This room should not be used for storage due to the moist environment and potential for leaks.

Water dispenser on carpet

6. Consider moving water dispensers to areas with non-carpeted floors or use a waterproof mat underneath.
7. Ensure the reverse osmosis system is maintained by the manufacturer. Inspect the drain periodically to ensure proper function. Avoid storing anything in this room that is not part of the reverse osmosis system.

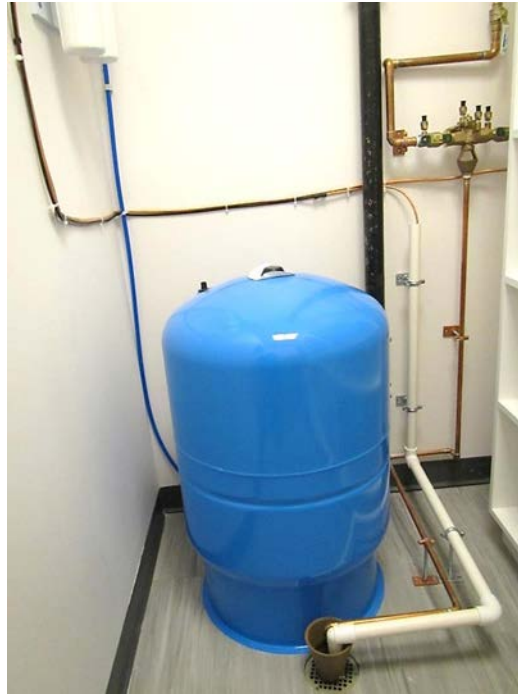
Picture 5

Reverse osmosis system in utility room

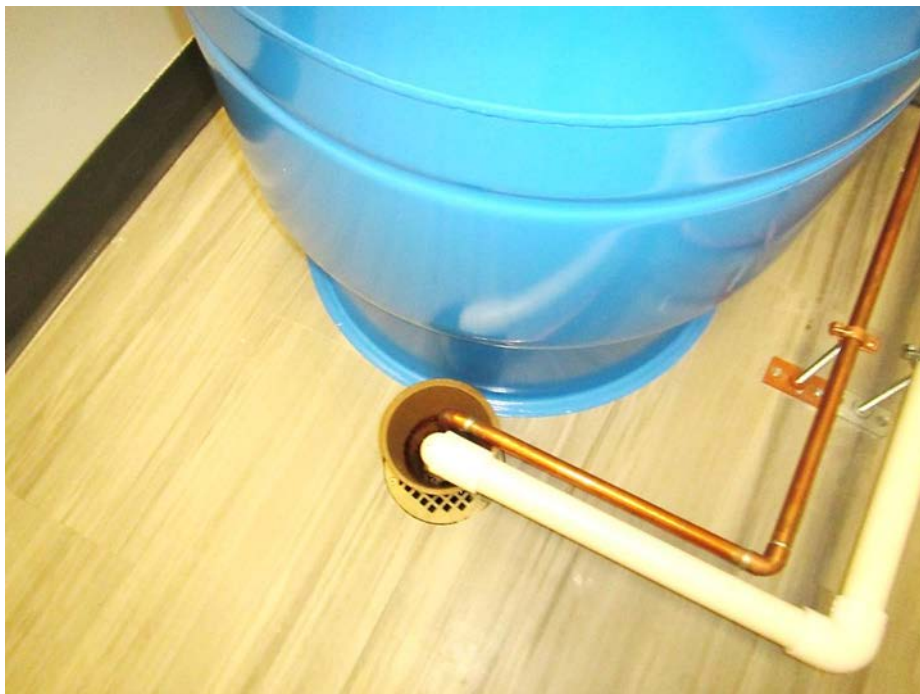
Picture 6

Drain for reverse osmosis system

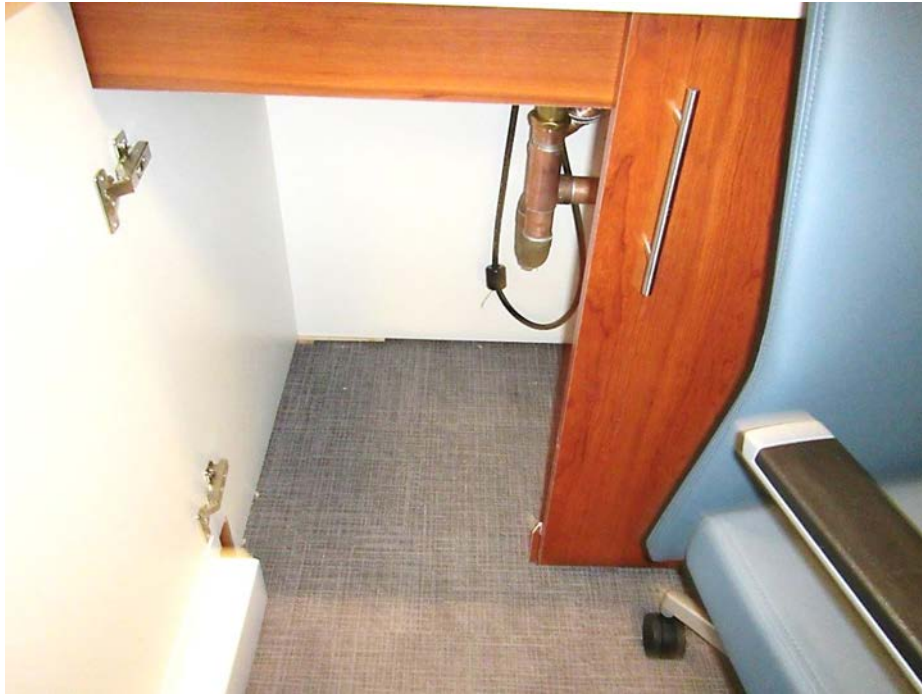
The cabinet under the sink in the large conference room was constructed without a bottom shelf, and carpeting had been placed in the area underneath (Picture 7). This condition will allow the carpeting to become moistened from leaks and condensation and likely lead to microbial growth. The carpeting under this sink should be removed and replaced with tile. Note that this is a punch-list item identified during the pre-occupancy visit that still needs completion.

Carpet underneath sink

8. Replace the carpet underneath the sink in Picture 7 with water-resistant flooring.
9. Reduce the use of cleaning products, sanitizers, and other items that contain VOCs.

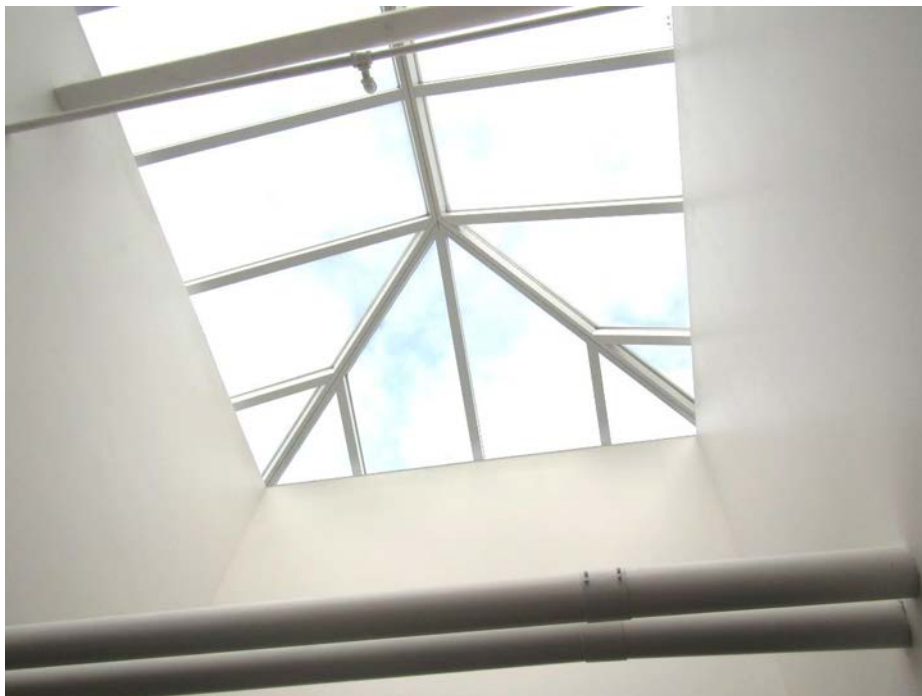
Picture 8

As indicated in the pre-occupancy report, a skylight was installed over a portion of this space after the staff had moved in (Picture 8). The skylight was installed on the weekend prior to this visit. Occupants reported some "chemical" odors that may relate to the installation, but also said the odors were less prominent later in the day as well as lessening over the week since the installation. No odors were detected during the visit and no TVOC readings above background were measured. Until the odors are completely dissipated, it is recommended that the supply and

exhaust ventilation be operated earlier in the morning than usual so that odors can be removed before staff are in the office.

New skylight

10. Ensure the ventilation system is running prior to occupancy each day until the odors related to the skylight installation and in the Interview rooms have dissipated.
